## **THE FORTIFIED HOUSES OF COUNTY CORK: ORIGIN, FABRIC, FORM, FUNCTION AND SOCIAL USE OF SPACE**

**Joe Nunan**

*This analysis of the origin, fabric, form, function and social use of space of the fortified houses in county Cork examines some of the changes that took place within Irish society in the late medieval and early modern period. The rise and decline of the fortified house reflects the passing of the Irish social, political, military and religious (Catholic) order and the rise of the new English elite determined to settle in Ireland. The builder/owners of fortified houses were the elites of Irish society who needed to secure and protect their property and valuables. The fortified house met the para-military and residential need of early seventeenth-century Ireland. It was a uniquely Irish architectural form that bridged the transition from tower-house building to the emergence of the undefended Irish country manor. It can be defined as the initial architectural form that identifies Ireland's move from the medieval to the modern world.*

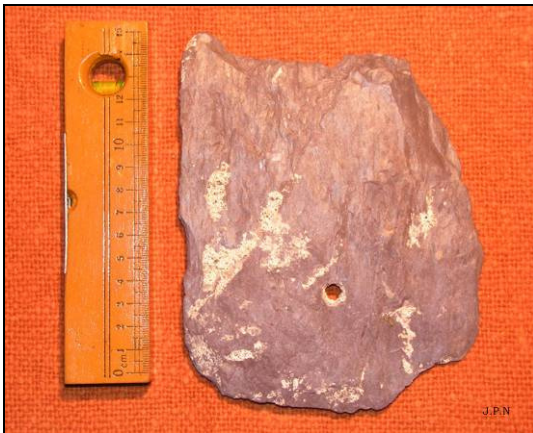
*Figure 2 – Roof slate from Dromaneen.  
(Photo: Joe Nunan)*

The Cork houses do not retain any of their original roofing material, but the surviving structures do give some indication as to the type of roofing that may have been used. At the fortified house complex of Dromanreen a partial limestone roof slate was identified lying on the basement floor, it may have been a damaged slate that was incorporated into the masonry work or it may have fallen from the house when it was de-roofed (Nunan 2005),

(Fig. 2). It was similar to the roof tiles dating to c.1641 uncovered during excavations within the grounds of Limerick Castle (Wiggins 2000). At Ightermurragh a sandstone roof slate was identified in the basement below the main entrance door (Nunan 2005), (Fig.3) and at Baltimore numerous limestone roof tiles were uncovered during excavations in 2002. Stone houses with slate roofs were being built in Munster in the early decades of the seventeenth century; Boyle's leases in Kinalmeaky and Carbery Co. Cork included precise instructions concerning the type of houses that were to be built with stone chimneys and slated roofs (MacCarthy-Morrogh 1986). North Devon decorated ridge tiles, however, were used at Baltimore (Eamonn Cotter pers. comm.) and these can be dated to the seventeenth century, after which there was a decline in their production with an increase in the production and use of plain ridge tiles. North Devon Gravel-tempered ridge tiles were found on excavations in Cork city at Philips' Lane and Grattan Street. Some of these tiles had thumb dressing, low cockscomb cresting and incised decorations on their exterior face (Wren 2003) and were probably imported into Munster through the various port towns. Finally, lead was used for roofing and rain water systems as it was the only material capable of keeping rain water out. Lead was rust free, malleable, but expensive and it was probably used on the roof at Mallow where according to Leask (1941), quantities of molten lead and fragments of thick, small slate were found during renovations.

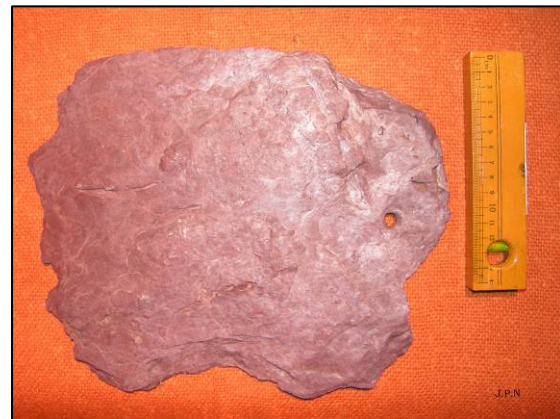
*Figure 3 – Roof slate from Ightermurragh  
(Photo: Joe Nunan)*

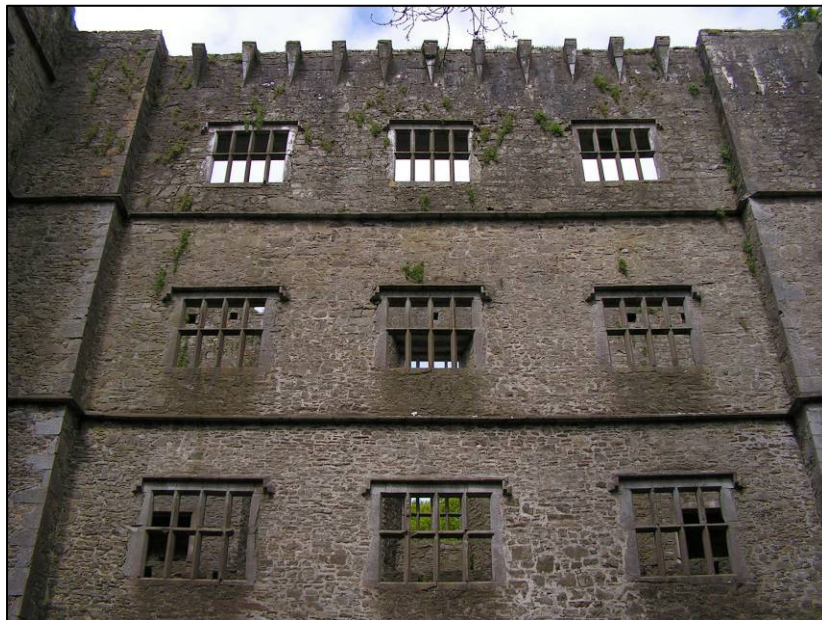
*Figure 4 – The large rectangular window was a distinctive feature of the fortified house (Photo: Joe Nunan).*

The large rectangular window was a distinctive and common feature of the fortified house (Fig. 4). The window surrounds were framed with cut stone; these frames contained vertical and horizontal inserts (mullion and transom) which were rebated for glass to secured paneled frames. Many of these mullion and transom windows were of a cavetto-type design. As a general rule the larger windows were those at some distance above the ground floor. At ground floor and basement level many of the openings on the outer wall were, for obvious reasons, of narrow width towards the outside and splayed inwards. Windows of this kind were commonly found on the lower levels of the buildings and on their projecting towers. The original window lintels were either large stone slabs or rectangular planks of cut oak. Many of the lintels were removed from the houses over the centuries. Some were destroyed by fire, or fell out while others were taken and re-used elsewhere. At Ightermurragh, Kilmaclenine and Kill-St-Anne South, the lintels either fell out or were taken, while according to tradition, at Mountlong, the house was burnt by its owner in 1643 (Fuller 1907), with a number of the wooden lintels surviving *in-situ*, some showing signs of burning.
